墾丁國家公園瓊麻工業歷史展示區 之規劃研究報告

墾丁國家公園瓊麻工業歷史展示區
之規劃研究報告

**Program and Recommendations for
Its Restoration**

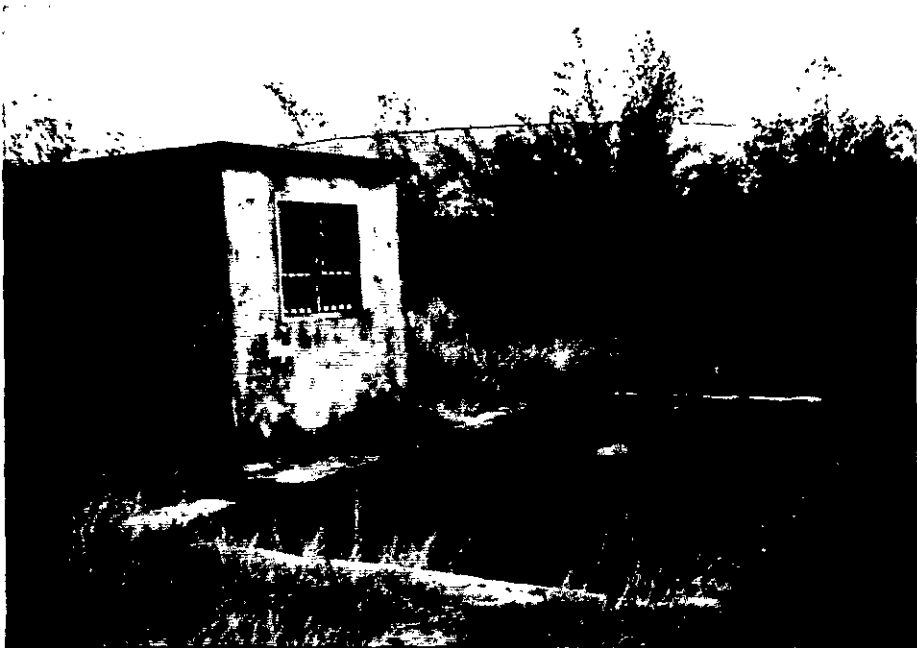
Like the decorticating machine itself, this needs to be cleaned up and brought back to working condition. The exterior of this machine is shown in Figure (14) and the interior in Figure (15).

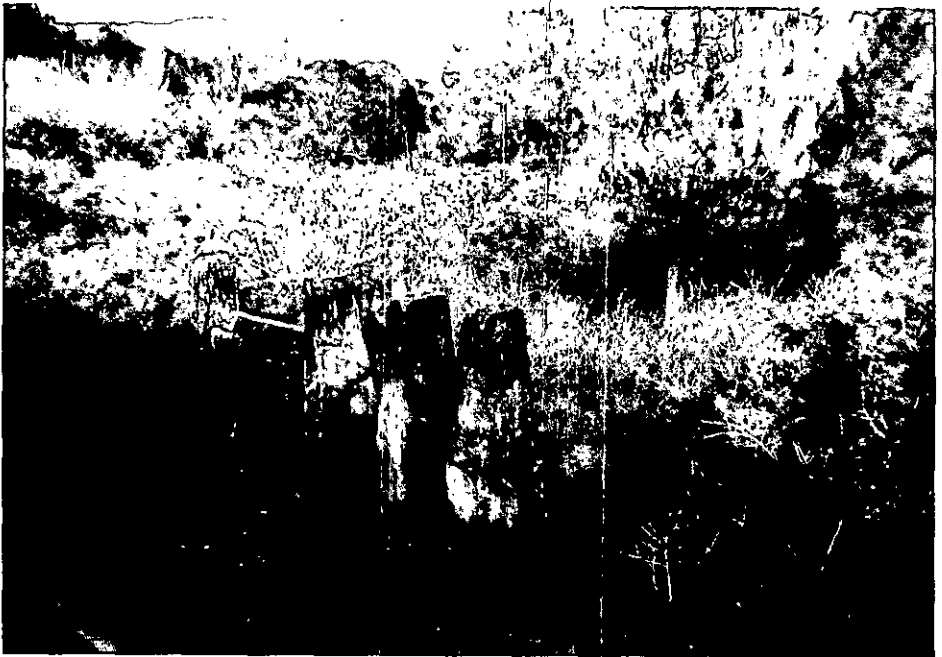
The concrete pylons in Figure (16) are located on Figure (1) and are next to the sisal plantation. This photograph shows extremely clearly the amount of brambles, shrubs and even trees which have grown up over the site. These all should

be cleared out so that the sisal plants themselves are uncovered. Grass turf should probably not be planted in the sisal plantation itself. A decision will have to be made after the entire clean up and repair process as to whether the plantation should be maintained or destroyed and covered with green grass. Also, the time at which the pylons were constructed needs to be determined and a description of their purpose and the machinery which was attached.

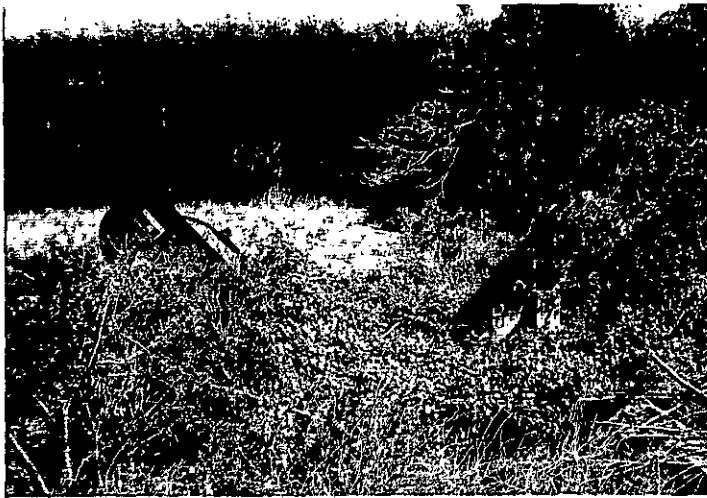
The device in Figure (17) needs also to be identified and described and of course the brambles around this equipment need to be removed.

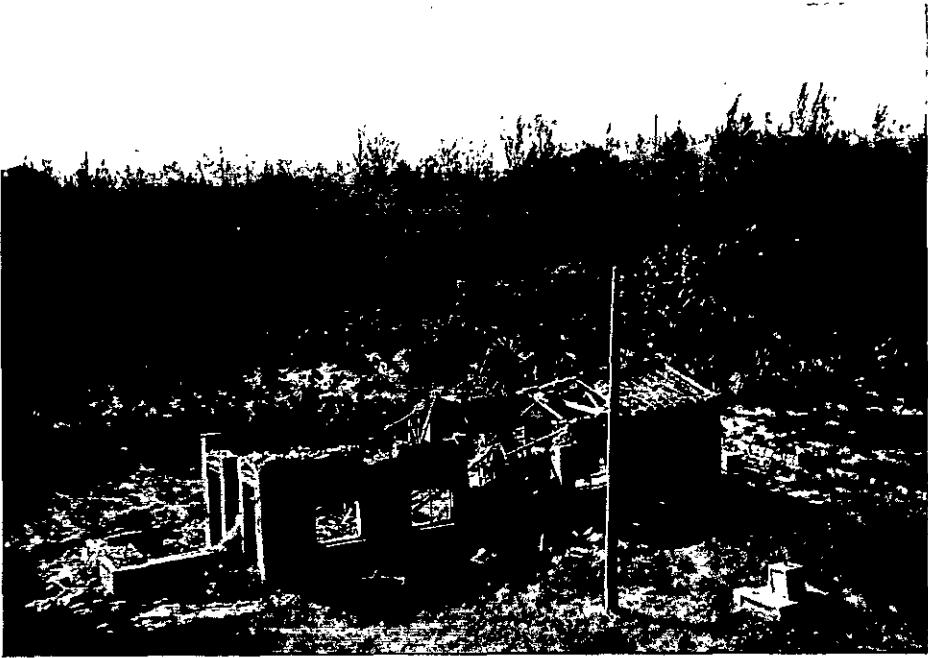
Figure (1)
(November 1986)

Although restoration of the Japanese buildings is a second priority, I would like to recommend strongly that means be found as soon as possible to protect the existing ruined structures. We were stunned to see how much additional damage was done by the typhoon last fall. In Figure (1) is a picture taken about a year ago of one of the buildings after the site was cleaned up and Figure (2) we took in December 1987 shows complete destruction of the roof and then part of the walls.

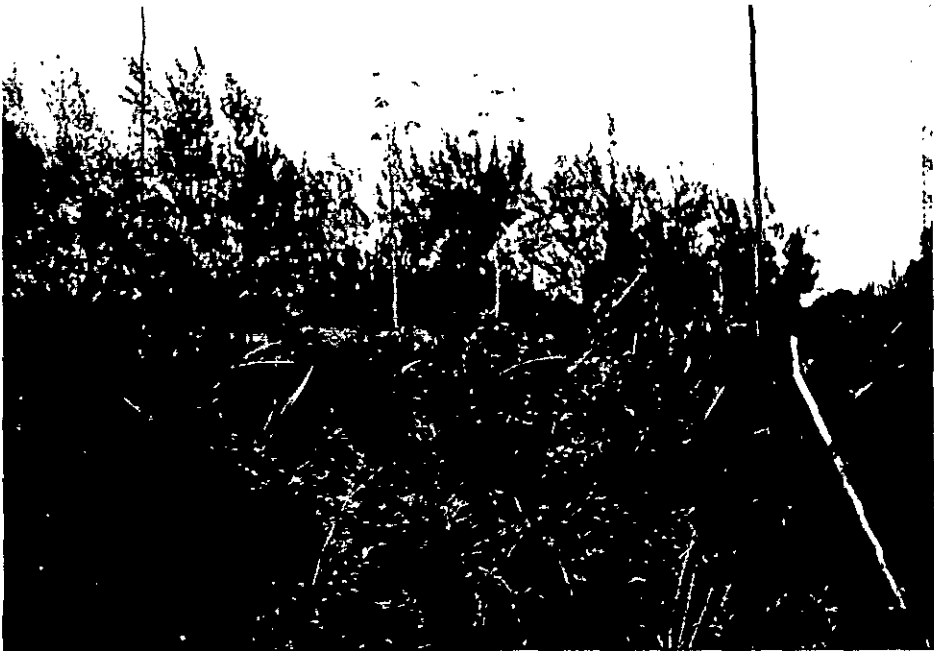
Figure (1)

The cactus plant, *AGAVE RIGIDA VAR SISALANA*, produces a fiber which under the name of sisal hemp has been used for many years to make the ropes and hawsers used in ships. As shown in the photograph, Figure (1), this plant produces a cluster of leaves which at the time of harvesting reaches a length of four feet. The fiber is contained inside the leaves which are covered by a heavy layer of pulpy material. The strength of the fiber is sufficient to withstand the force required to scrape off the pulpy material. The scraping process is called decortication and over the years has been carried out by a variety of devices.

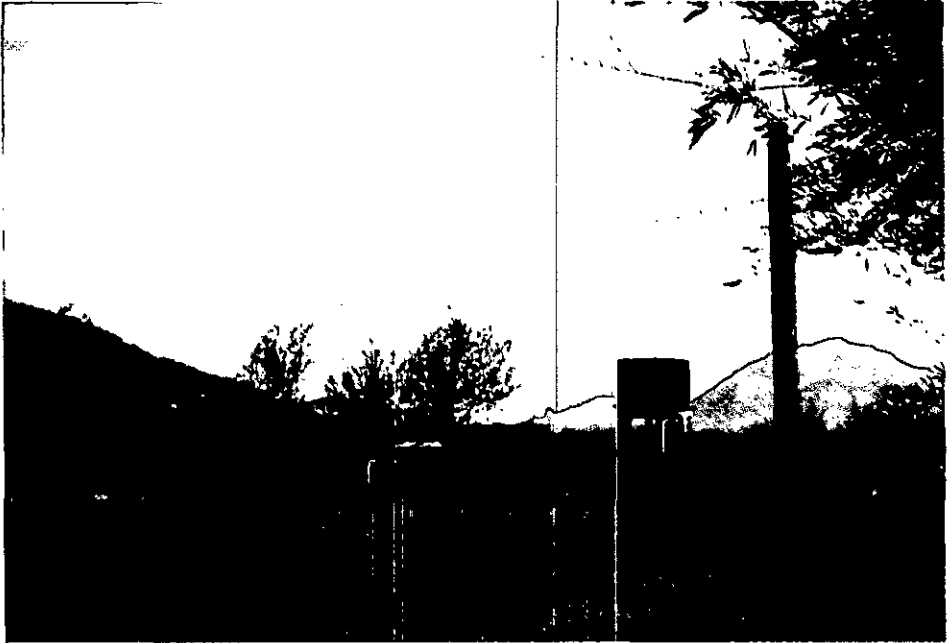
In Figure (3) and (4) are the smoke stack and support for the machine which in 1987 still stood in this site. Both machines were mounted on an elevated platform which was placed on top of these supports.

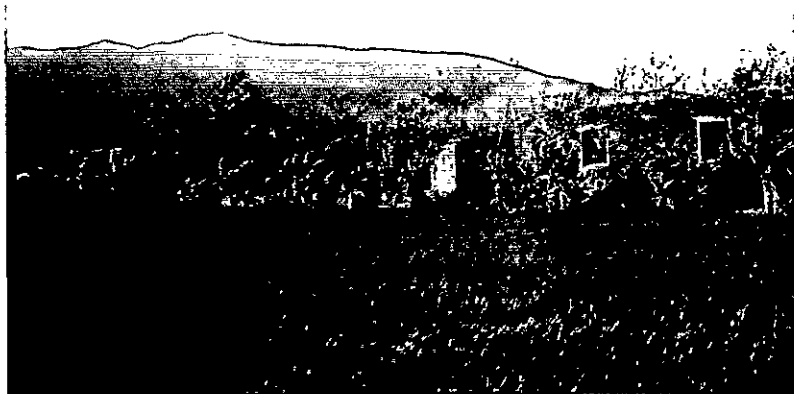
Across the field as shown in Figure (5) were the extensive ruins of the Japanese buildup which we were told were warehouses. During our first visit in December 1986 the field grew melons. In this May 1987 photograph, the field has become a rice paddy. In Figures (6) and (7) are closer views of these ruins.

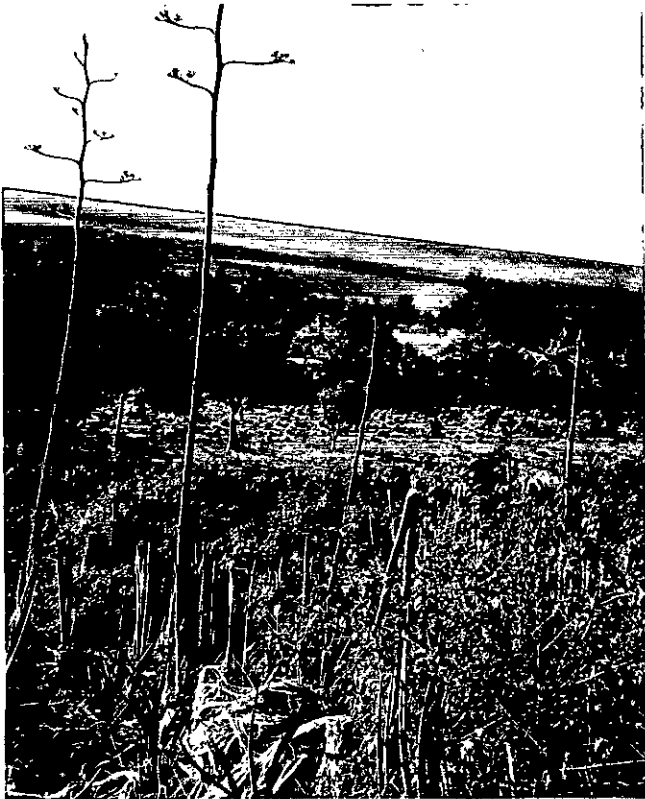
Figure (11)

Small machines of this type are still used in Taiwan. They are run with gasoline engines and on a sunny day are carried by farmers into these private sisal fields. The leaves are cut and carried to the decorticator which is usually set up under an awning. We discovered this operation by accident when we noticed the awning in the middle of a large sisal area along the coast. In Fig. (8) is a photograph showing how the leaves are fed by hand into the machine. The operation of the decorticator is the same as for large machines. A wheel with ridges rotates at high speed inside a cylindrical cover. The leaves are pushed into the machine to the point where the ridges scrape off the pulp and leave only the fiber. The operation can be dangerous since if the person holding the leaf moves her hand in too far she can lose some fingers. Fingerless people can be noticed in the Heng Chun area. In Fig. (9) is the pile of leaves ready to be fed into the small machine and some of the sisal plants which have been harvested. The next photograph Fig. (10) shows the belt drive which runs the cooling fan as well as the machine. The view from this site is in Fig. (11).

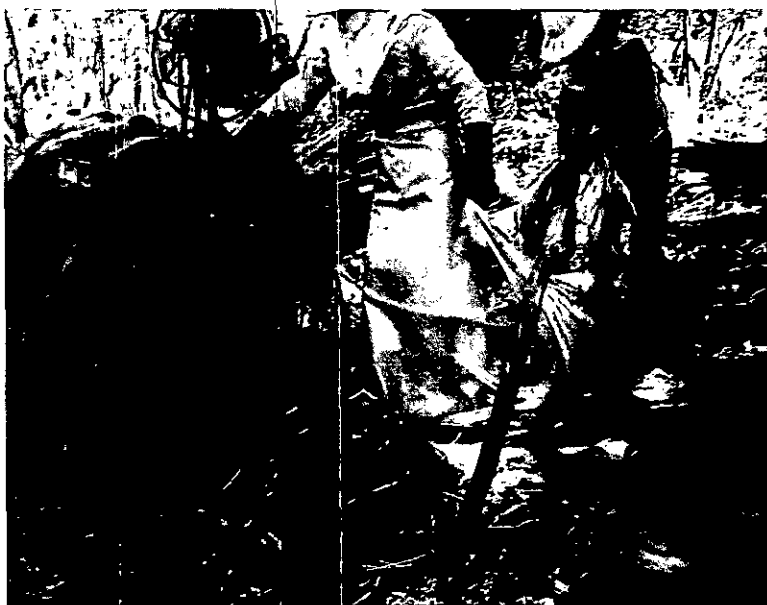
Figure (12)

Further down the coast towards Mau Pi Tou we found a farmhouse beside the road which was at the edge of a plantation with a small machine operating. The machine and the field belonged to a farmer. It also was belt driven and had a cooling fan for the operators as shown in Fig. (12). Like the previous small machine operation the cut cactus plants were used as a drying yard which can be seen in Fig. (13). Fig. (14) shows the farmhouse and the area used for packaging the dried sisal fiber.

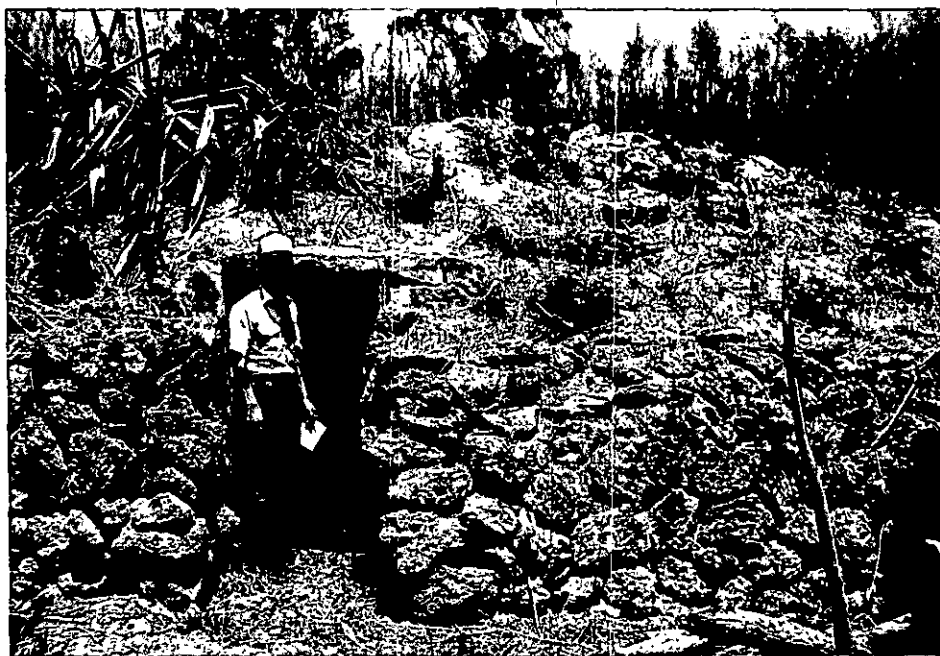
Figure (16)

At the time of acquisition, the area was extensively overgrown and difficult to explore. As a first step in preparing the site, the field was cleaned up of brambles and shrubs. As a result of this operation, many items which people had forgotten were uncovered. Perhaps most startling was the discovery of the three Japanese air raid shelters which were probably constructed during World War II when part of this area was bombed. A photograph of one shelter is shown in Figure (16).

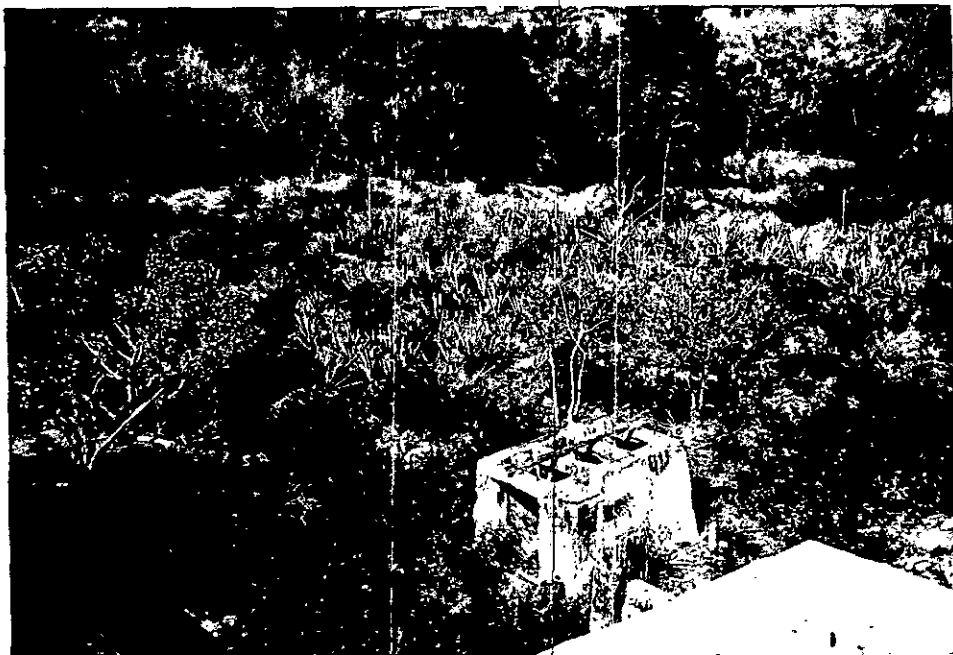
Figure (20)

In this area the large Japanese machine was supported on the second floor of a building by a heavy concrete structure as shown in Figure (20). Next to the stand is a sisal plantation which previously was completely hidden by brambles.

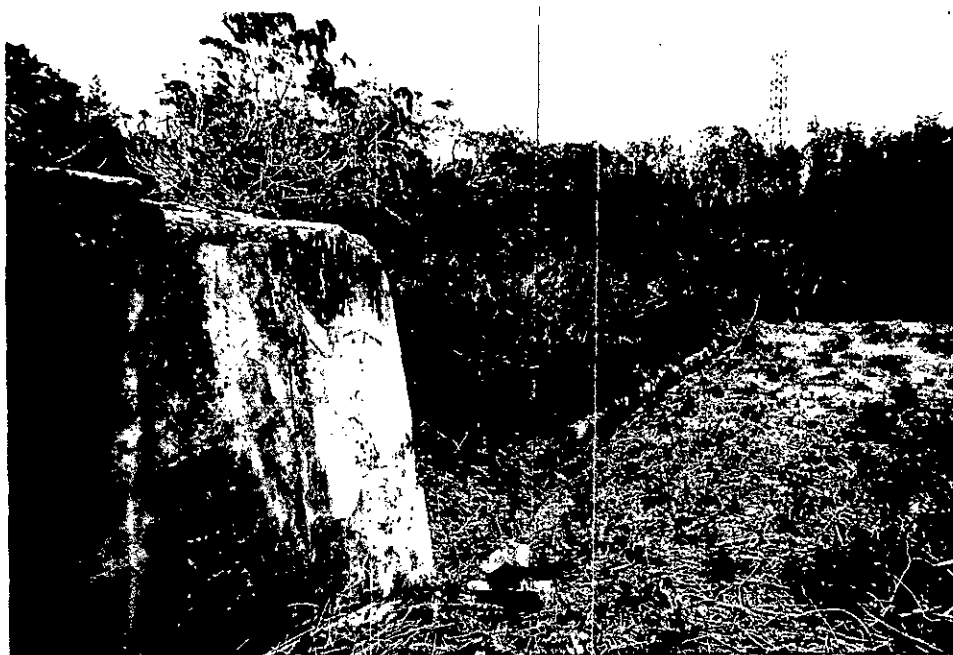
Figure (21)

Since a large amount of water is used in the machine, a concrete channel was constructed to carry the sludge and waste water to the small stream at the edge of the field. This channel has not been used since Japanese times and is quite ruined as shown in Figure (21).

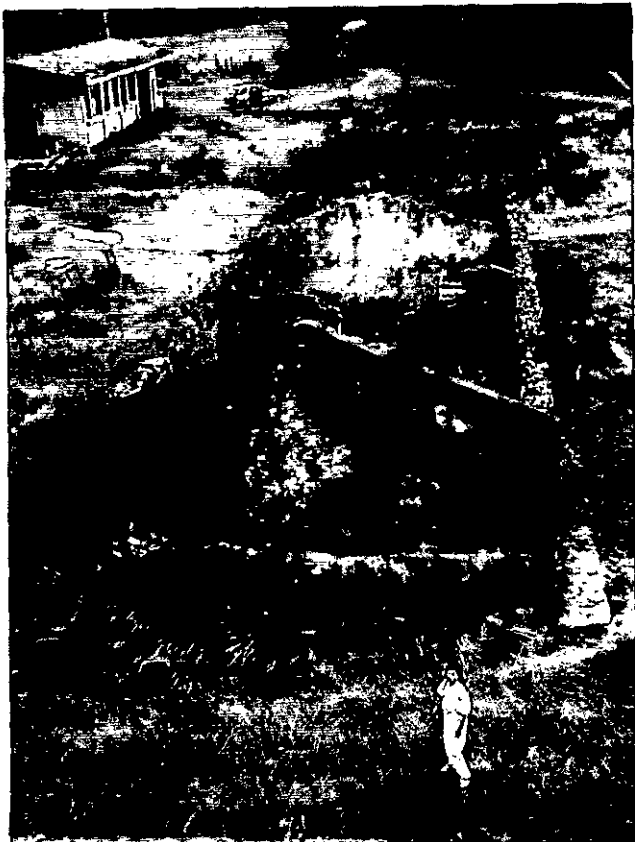
With the destruction of the large automatic decorticating machines, an attempt was made to fill the same function by typing together a series of 14 small machines which were run by a single belt from an approximately 40 h.p. diesel engine. These were placed in a building with a single concrete water channel underneath the machines. Only the foundation of this building remains today and is shown in Figure (22) just beyond the first ruined building.

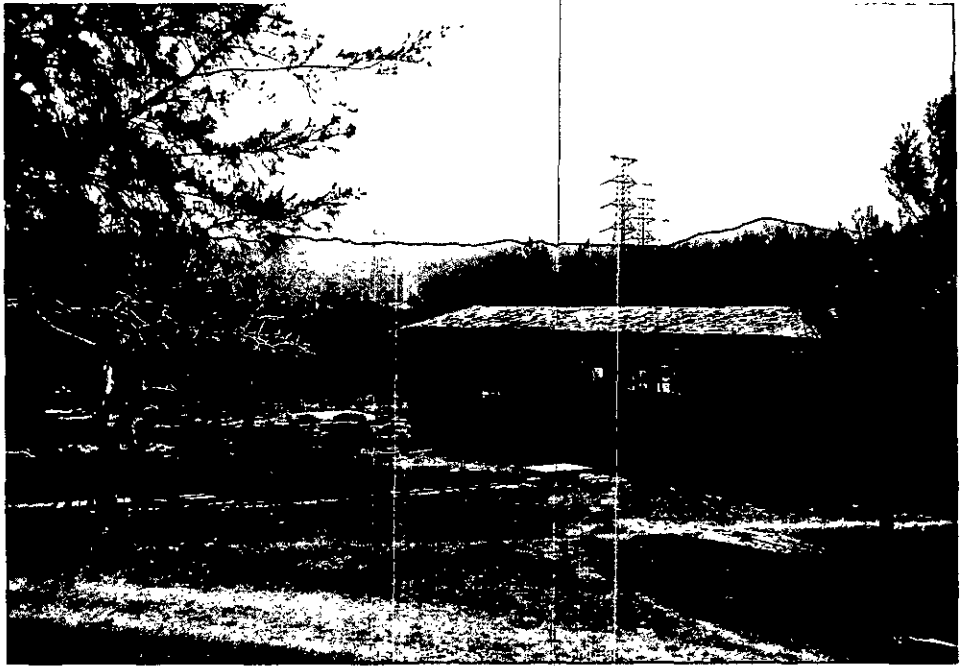
In some ways, the most important item in the Kenting National Park Sisal area is the British machine itself. This is in the building shown in Figure (23) along with the track and some of the carts which carried sisal leaves into the machine.

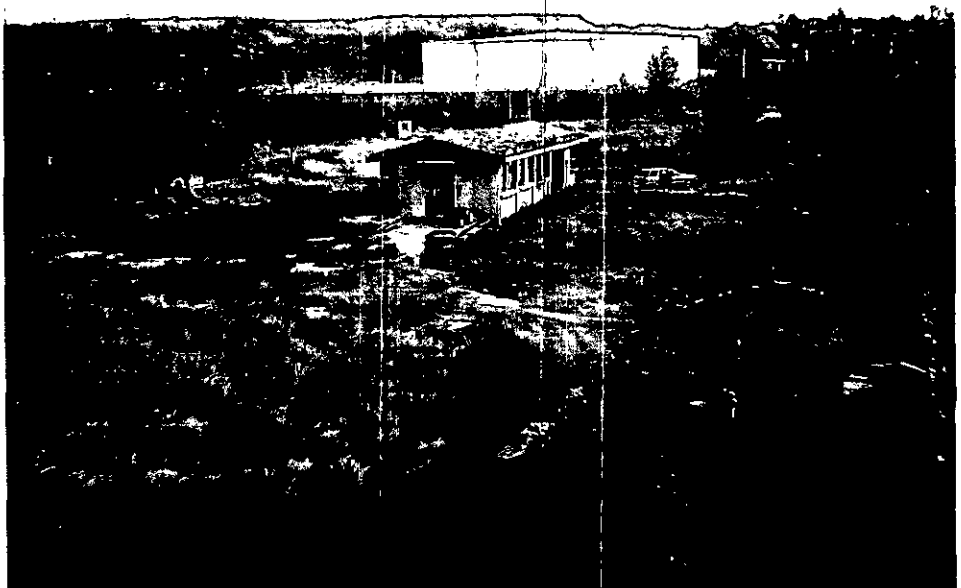
In Figure (24) is another view of the building with the oil storage tank in the background. Trees should be planted to conceal the tank.

As a second recommendation, I would like to propose that trees be planted at the edge of the field to hide the large oil tanks. Again, fast growing and reasonably foliated trees can be provided. They often can be transplanted at a point where they are already partly grown and in mere seedlings.

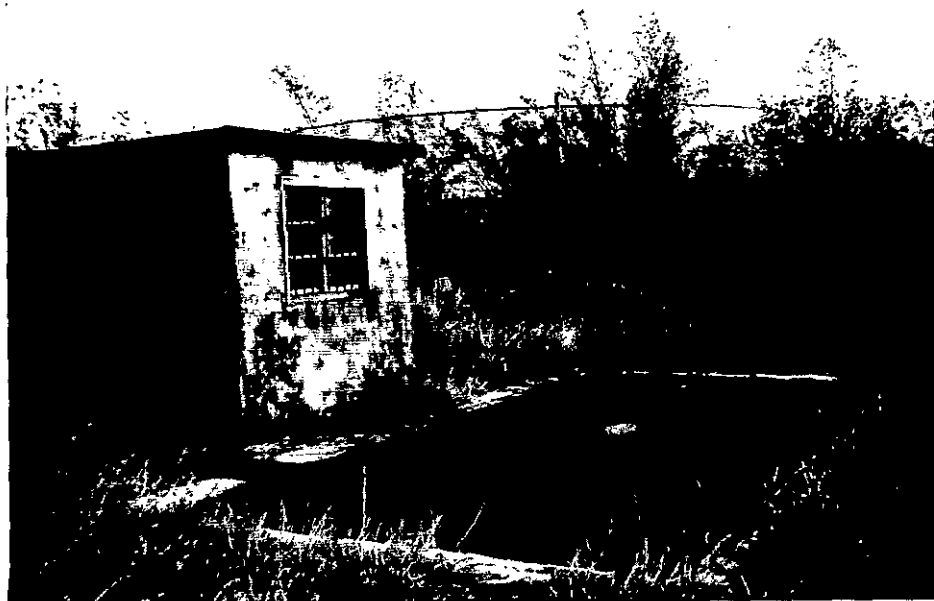
The sisal went first to the weighing scale shown in Figure (26) and then along the tracks in Figure (27) and finally into the building housing the large machine. The original Japanese inbound tracks are shown in Figure (28).

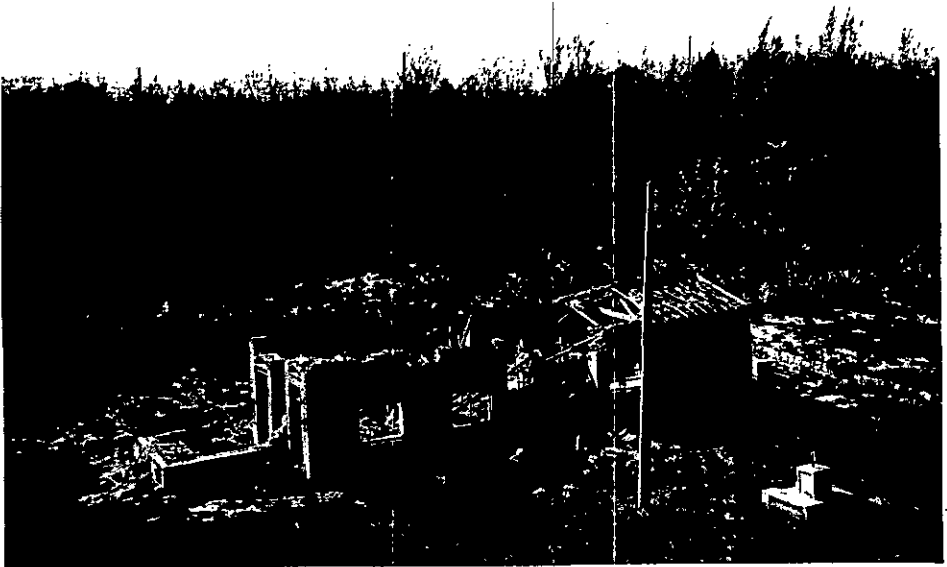
Figure (32)

Throughout the historical site are many ruins and artifacts. Most conspicuous are two Japanese dormitories. One will be completely restored. The other will be preserved in a way to show the details of their interesting construction. Figure (30) and (31) show one of these buildings. The other is in Figure (32).

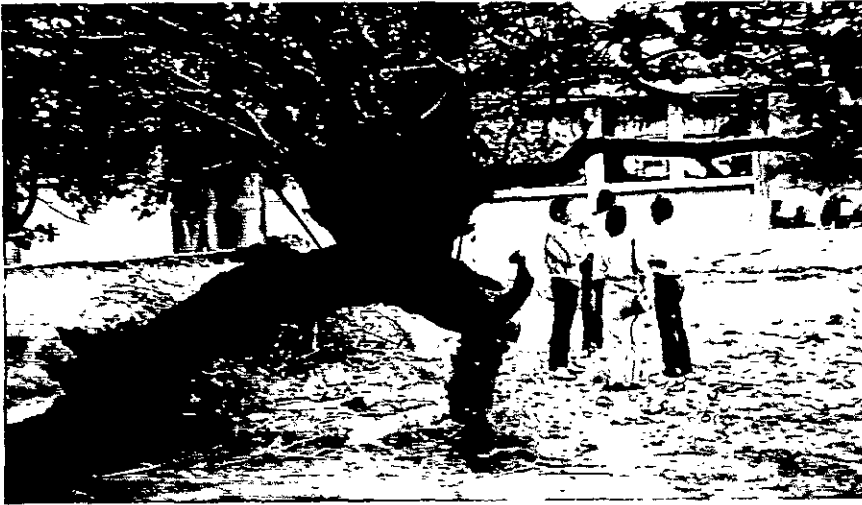
Many of the items in the field have still not been identified. One concrete foundation shown in Figure (33) is interesting because of the presence of this tree. The age of the tree can be easily determined and will give a clue as to when the cement was laid down.

4. We recommended previously that it should be possible to estimate the latest time at which the concrete layers were placed over one area in the site. A good sized tree has grown through the concrete and as I proposed earlier, an expert should be able to determine the age of this tree and thus the latest time at which the concrete was laid. This tree has been pretty much demolished by the typhoon and it would be advisable to make the measurement soon. The Forest Service or the Council of Agriculture can certainly identify an individual who could get the answer.

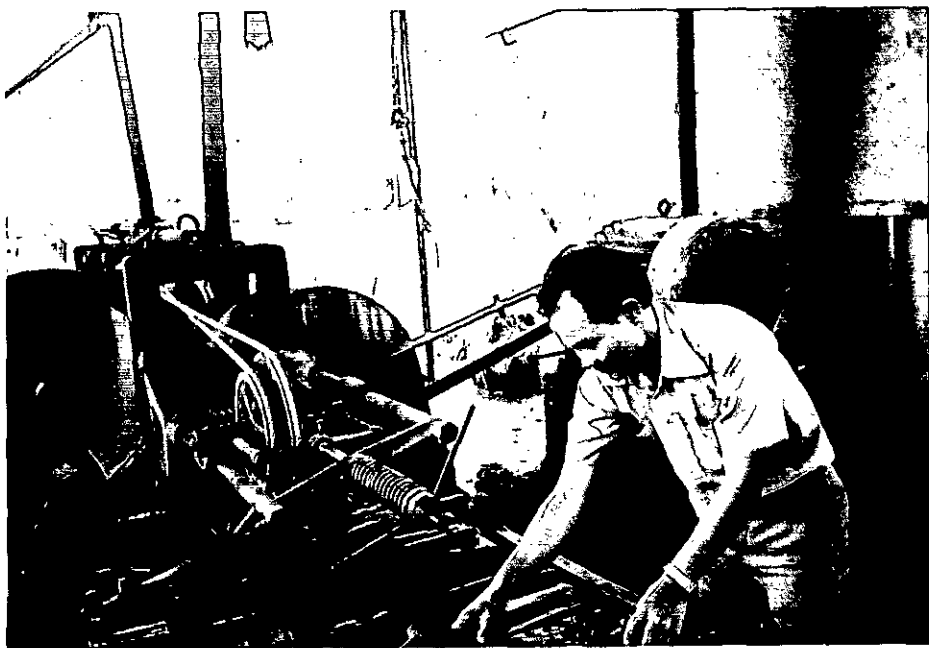
Figure (36) and (37) show the operation of one of the machines in Kuanshan. This was partly owned by a former mayor of Hengchun.
